GEOLOGIC CONTROL OF SAND BOILS ALONG MISSISSIPPI RIVER LEVEES

Charles R. Kolb

**MISCELLANEOUS PAPER S-75-22**

August 1975 Final Report

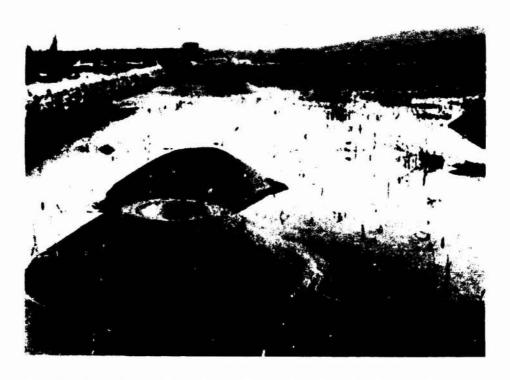
Figure 1. Sand boils rising above the water level of a sack sublevee near Friars Point, Miss., 1937 high water.

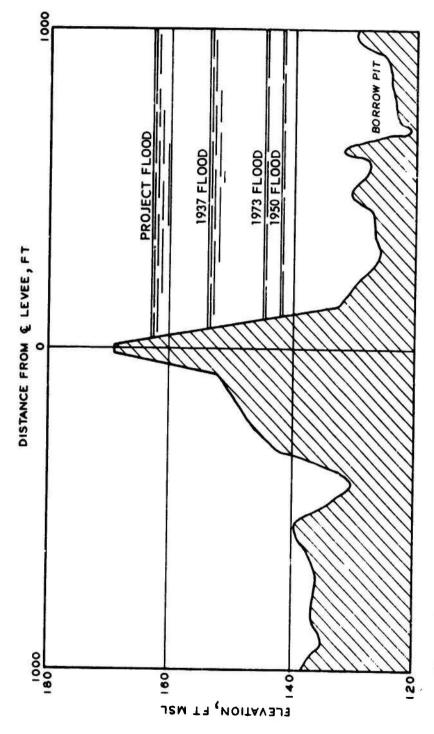
Figure 2. Surface profile along a typical levee showing crest heights of three major floods and of the project flood. Profile taken on east bank of river at levee station 2860.

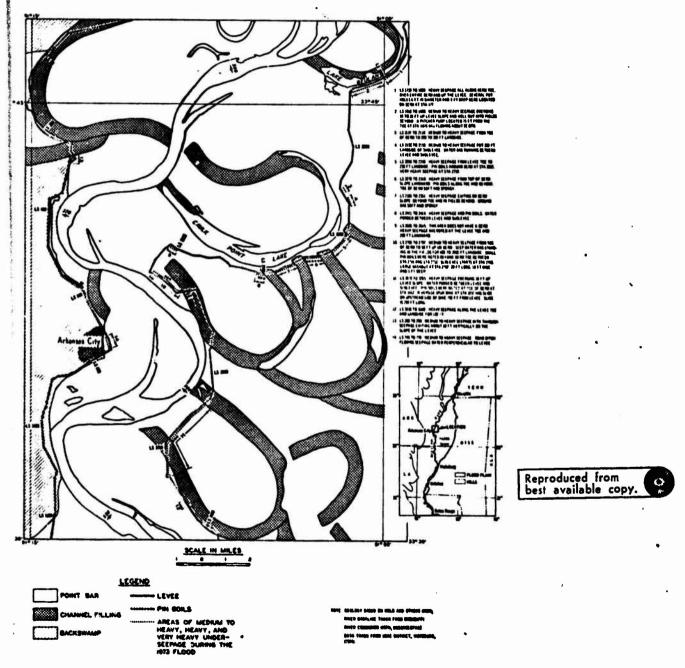
Figure 3 summarizes the underseepage data collected during the 1973 flood in a 40-mile reach of the river which includes Arkunsas City, Arkansas. The river reach was more or less randomly selected. Levees are shown in this figure with an appropriate symbol. Levee stations are shown at 20,000-ft intervals. Landside areas where moderate to heavy, heavy, and very heavy seepage occurred are symbolized in Figure 3 and notes taken by the survey parties along such seepage areas are summarized. Areas of light and moderate seepage recorded by the survey parties are not shown. An asterisk is used to indicate areas where pin boils were reported.

Figure 3 nicely illustrates the effect of backswamp clays on underseepage where such clays underlie the levee. From approximately LS 300 to 1200 on the west bank of the river, the levee is built on backswamp clays. Significant underseepage in this extensive levee reach occurred only from LS 280 to 290, and at Arkansas City between LS 745 and 770. In both instances the levee is so aligned that it extends over small portions of point bar deposits. Note also the extensive borrow pit in the levee setback opposite river mile 570. This illustrates location of riverside borrow pits in deposits, which, because of their thickness and impermeability, have no effect on underseepage.

Note that seepage through the clay channel fillings is rare in Figure 3. However, significant seepage was recorded through the lower arm of the clay plug at seepage reach 11. This is probably due to a thick sand filling in this lower arm of the clay plug at the time of cutoff. Seepage reach 12, between levee stations 3330 and 3340, also occurs in a mapped clay plug. More detailed mapping and a boring or two might clarify what appears to be an anomalous situation.

Figure 3. Geologic environments of deposition along a typical reach of the Mississippi River. Areas of significant seepage and of pin boil development during the 1973 flood are shown.

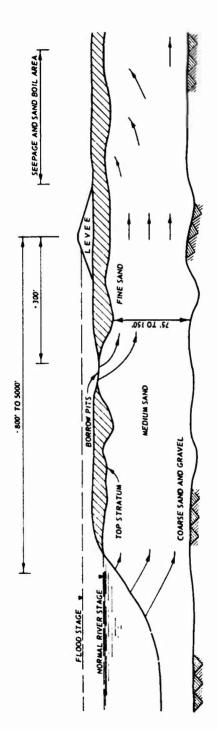
A convenient distinction in the Mississippi Valley as in other alluvial valleys is that between a more or less impervious, fine-grained topstratum and an underlying substratum of sand. Figure 4 schematically depicts the topstratum-substratum relationship at right angles to a typical levee, the irregular thickness of the topstratum, and the depth to the generally impermeable Tertiary horizon (to be discussed more fully in the following section). Note the generalized seepage pattern as flood flows rise against

100 to 400 ft below the level of the present floodplain. As sea level began to rise about 17,000 years ago remnant sands and gravels within the entrenched valley were covered by additional sands and gravels and at higher levels by sand alone. As a result, a variable thickness of sand and gravel lies above an irregularly eroded and relatively impermeable basement of Tertiary and pre-Tertiary deposits (Fig. 4).

Figure 4. Generalized geologic cross section beneath levees in the Arkansas City area. Relatively impervious topstratum is underlain by pervious substratum, which is, in turn, underlain by Tertiary clay.

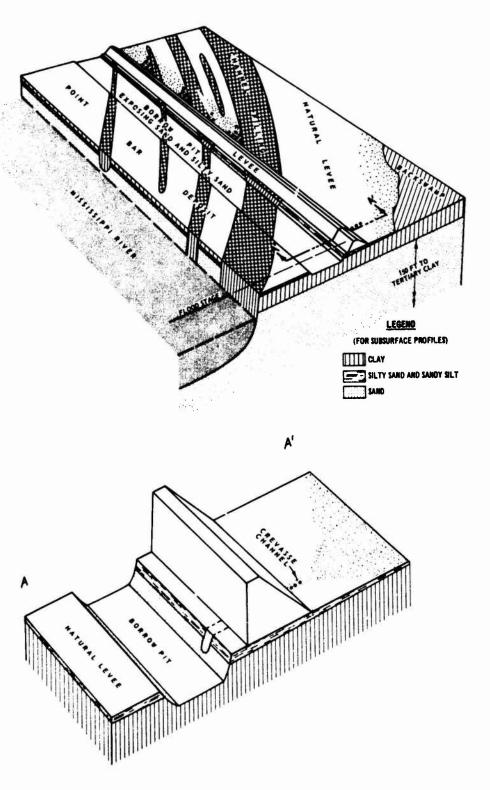
Figure 7 shows the effect of these elongate clay bodies on underseepage, particularly where they pass beneath a levee at an acute angle. Seepage is often heaviest and boil formation most marked within the acute angle. The clay body tends to concentrate seepage in the pervious ridge areas where the geometry of the levee vis-a-vis the trend of the swales resembles that shown in Figure 7. Note that boils also tend to form adjacent to the swale within the obtuse angle formed by the swale and the levee. However, such seepage is generally less pronounced. Figure 8 illustrates the distribution of boils where swales cross beneath levees at roughly right angles. Boils still concentrate in the ridge soils next to the clay swales, but their distribution is more random than in the case shown in Figure 7.

An important and often critical factor illustrated in Figure 7 is the effect of borrow pits on the riverside of the levee in initiating or increasing underseepage. Borrow for the levee, particularly during the early years of levee construction, was often taken directly riverside of the levees. Such pits often expose impervious underlying sand and silty sand and provide ready access for seepage of floodwaters beneath the levee. An important underseepage preventive measure has been to locate such borrow areas only where they do not expose underlying pervious strata. Where critical underseepage conditions are caused by borrow areas the areas are often filled with impermeable riverside blanket. No attempt has been made in Figure 3 to delineate borrow pits which may affect the localization of underseepage.

Figure 7. Clay channel fillings and swales crossing beneath levees at an angle. Boils tend to form in point bar deposits within the acute angle between the levee and the clay body. Boils (shown with asterisks) and seepage (shown with a dot pattern) are generally absent in backswamp deposits. A special case is illustrated in the expanded section shown along A-A'. Here a well developed, semipervious natural levee deposit lies between the backswamp clays and the artificial levee. In such instances seepage may occur in the extreme landward portions of the natural levee and in old natural levee crevasses backfilled with sand.

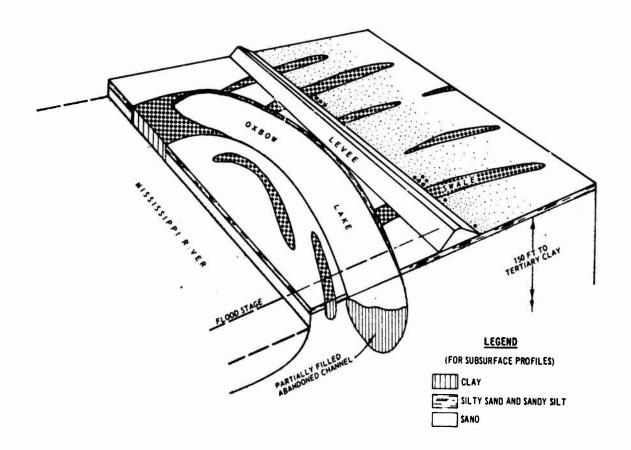
Figure 8, introduced previously, illustrates a situation somewhat analogous to the seepage problem occasioned by a riverside borrow pit. In this instance the seepage source, however, is a partially filled abandoned

channel, an oxbow lake, occurring close to the riverside of the levee. Such partially filled channels permit ready access for seepage beneath the levee and when point bar deposits flank the landward side of the levee, boils  $\varepsilon$ nd underseepage are common. Cases in point are seepage reaches 1 through 8 in Figure 3 where oxbow lakes Beulah and Caulk Point lie just riverward of the levee and furnish a source for underseepage through the levee.

Figure 8. Where swales and channel-fill clays cross beneath the levees at more or less right angles, boils are fairly randomly dispersed and not as frequent or severe as when an acute angle is formed between the levee and the clay bodies. In this case an oxbow lake partially filling an abandoned channel is a serious source for seepage of floodwaters beneath the levee.

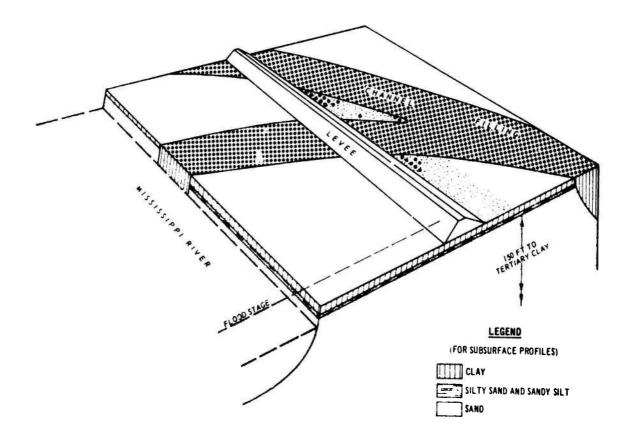
Figure 9 shows the effect of one such abandoned channel fill on seepage. In this instance we are dealing with a split abandoned channel, one which once contained an island in the cutoff loop—a fairly common occurrence in the Mississippi Valley. Because of the geometry of the clay plug and the angle at which it is crossed by the levee, seepage and sand boils are particularly troublesome in the cul-de-sac represented by that part of the former river island just landward of the levee. Boils are also common where the clay plug or channel fill forms an acute angle with the levee. This is similar to the situation previously described where the smaller clay swales cross beneath the levee at acute angles.

Figure 9. Effect of a split channel filling on localizing seepage and sand boil formation.

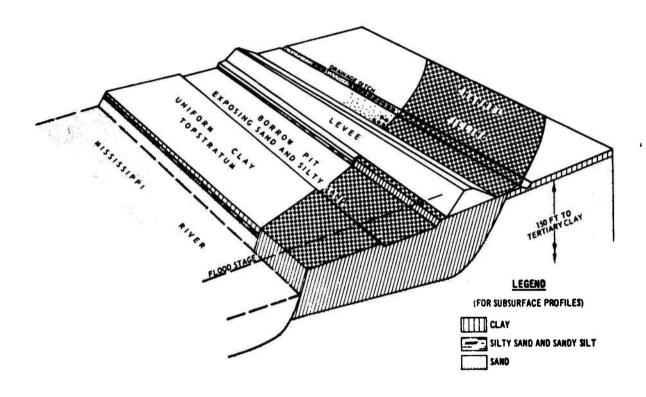
Figure 10 shows a similar situation. In this instance a borrow pit flanks the riverside of the levee and a drainage ditch penetrates fairly permeable material some distance from the landside toe of the levee. Boils and seepage are found in the acute angle made by the channel filling with the levee, but the most pronounced drainage and boil development are in that portion of the drainage ditch which has partially penetrated the clay and silty topstratum.

Because the drainage ditch is at some considerable distance from the levee toe, boils are frequent but movement of subsurface material to the surface and the danger of piping are negligible.

Figure 10. Drainage ditches penetrating fairly permeable materials on the landside of the levees are usually the sites for heavy seepage and boil formation. Borrow pits on the riverside of the levee, which have removed impervious topstratum, greatly accentuate the problem.
